Stormwater Capture Parks along the Henry Hudson Parkway: Developing Endor Garden as a Watershed Model

The purpose of this proposal is to describe a model framework for the **Henry Hudson Parkway Scenic Byway** coupling parkland creation with overpass infrastructure along the Henry Hudson Right-of-Way in the Bronx. This program was developed by the Gaia Institute in partnership with the Riverdale Nature Preservancy, funded by the J.M. Kaplan Fund.

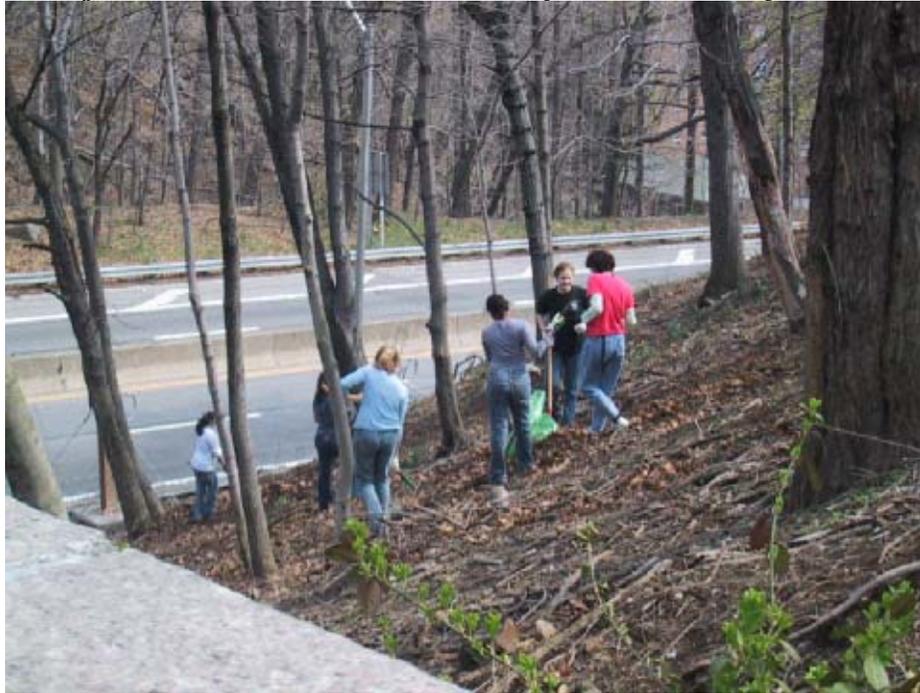
Terraced planting enables the once bare slope to capture water in soil, and support a dense, multi-layered, vegetated buffer.

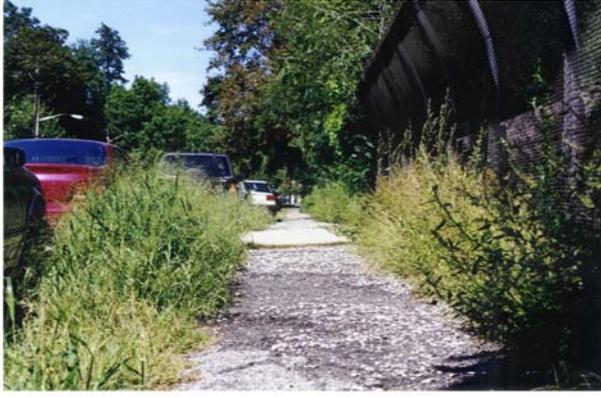
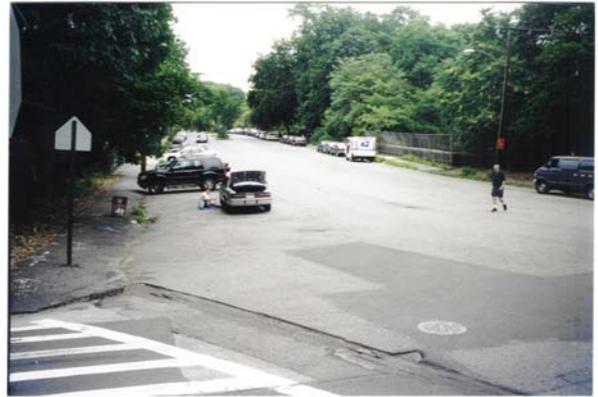
When the New York City Department of Parks and Recreation collaborated on a design for four GreenStreet beds on the Fieldston Road Overpass, vibrant plantings increased soil and vegetated cover adjacent to the paved surfaces. These dense, verdant landscapes have transformed a previously sterile public space into an inviting esplanade.
