# Stormwater Capture Parks along the Henry Hudson Parkway: Developing Endor Garden as a Watershed Model

The purpose of this proposal is to describe a model framework for the Henry Hudson Parkway Scenic Byway coupling parkland creation with overpass infrastructure along the Henry Hudson Right-of-Way in the Bronx. This program was developed by the Gaia Institute in partnership with the Riverdale Nature Preservancy, funded by the J.M. Kaplan Fund.

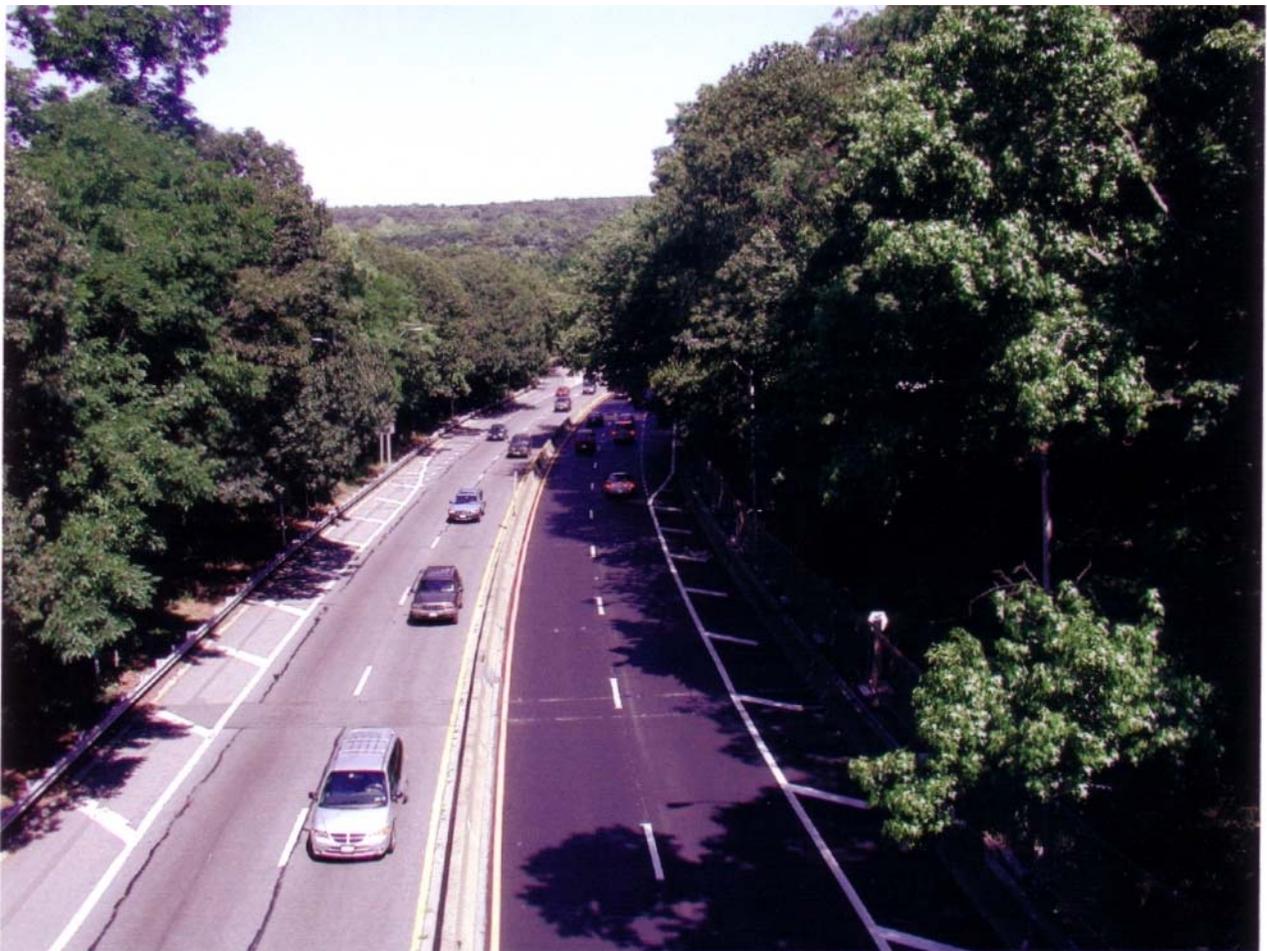
*View from the Fieldston Road Overpass of the Henry Hudson*

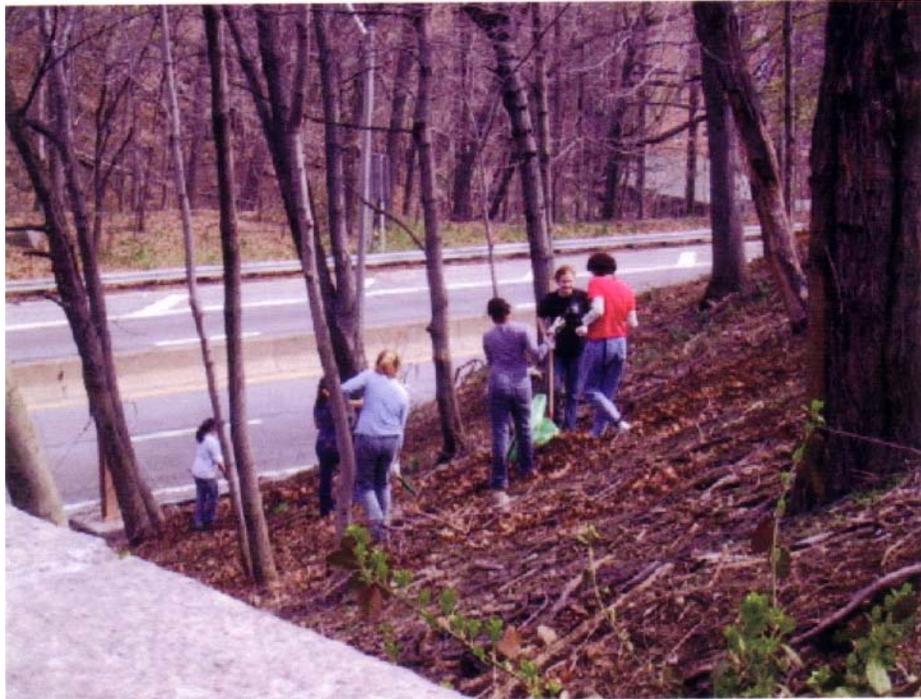
Parkland Adjacent to the Fieldston Road Overpass of the Henry Hudson Parkway

Terraced planting enables the once bare slope to capture water in soil, and support a dense, multi-layered, vegetated buffer.

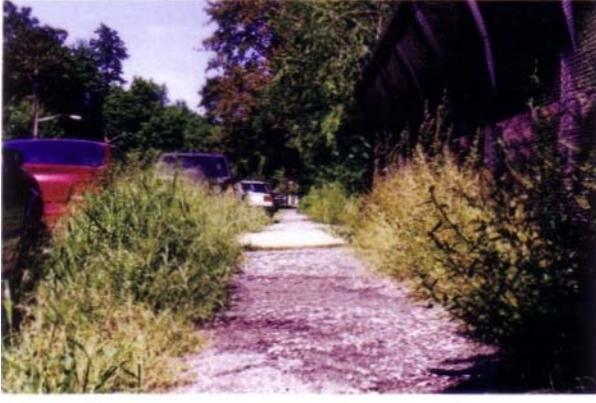
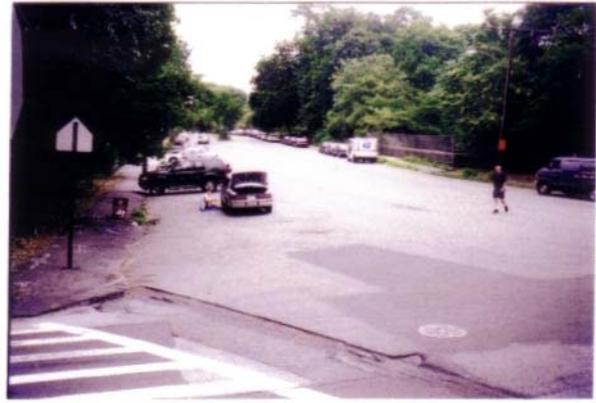
The Parks Department collaborated on a design for four GreenStreet beds on the Fieldston Road Overpass that maximize the soil to pavement ratio, supporting a denser landscape and transforming a blighted public space into a beautiful one. Entrance to Endor Community Garden (below).
